# Street and Roadway Inventory and Condition Assessment

**Town of Benson**

**Revised: January 9, 2018**

**Enoch Engineers, PA**  
1403 NC Highway 50 South  
Benson, NC 27504  
Phone: (910)894-7765  
Fax: (910)894-8190

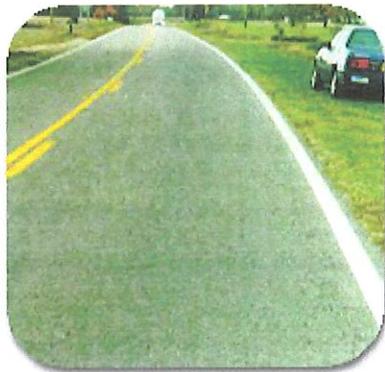
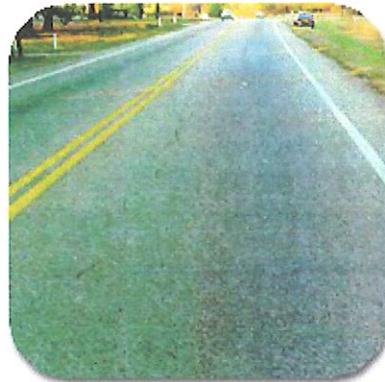
**Light:** Longitudinal disconnected hairline cracks about 1/8 inch wide running parallel to each other; initially may be only a single crack in the wheel path but could also look like an alligator pattern; sealant is satisfactory for sealed cracks.

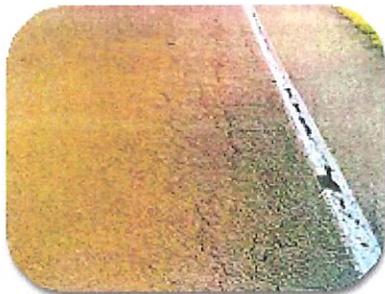
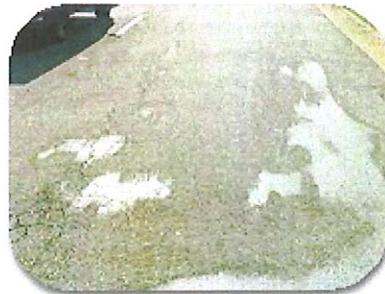
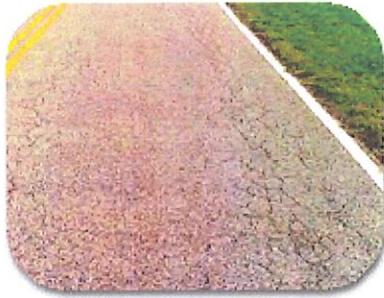
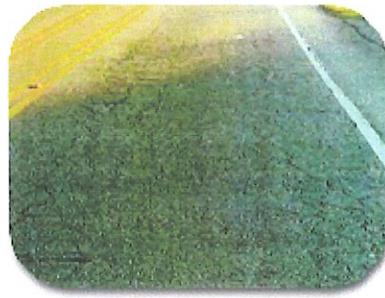
**Moderate:** Longitudinal cracks in wheel path(s) forming an alligator pattern; cracks may be lightly spalled are about 1/4 inch wide.

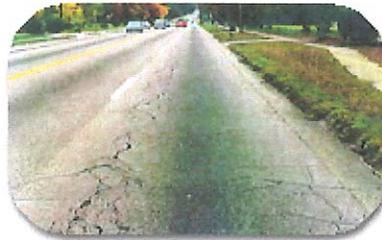
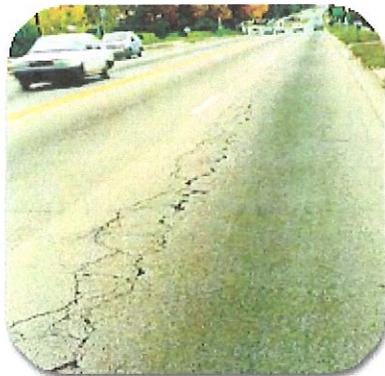
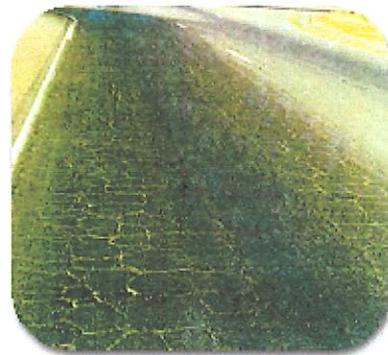
**Severe:** Cracking has progressed so that pieces appear loose with severely spalled edges; cracks are probably 3/8 -1/2 inch wide or greater; pumping of fines through the cracks may be visible on the pavement surface; potholes may be present.

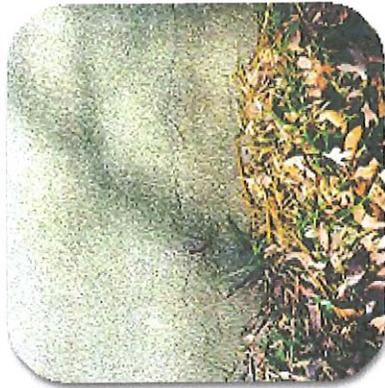
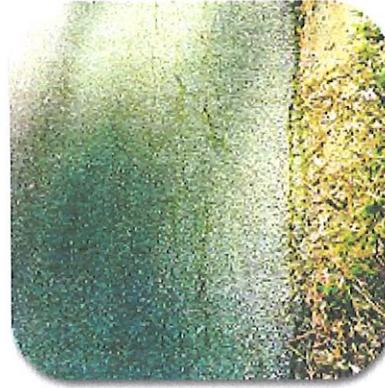
## ALLIGATOR CRACKING (Edge)

**Light:** Hairline cracks just beginning to show; are random with no pattern; cracks may be 1/8 inch wide.

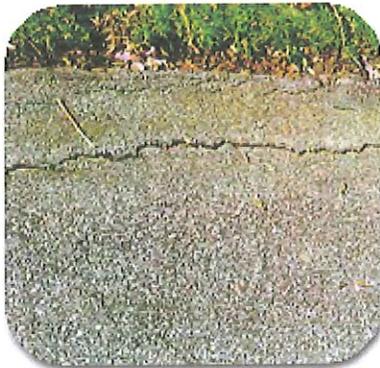
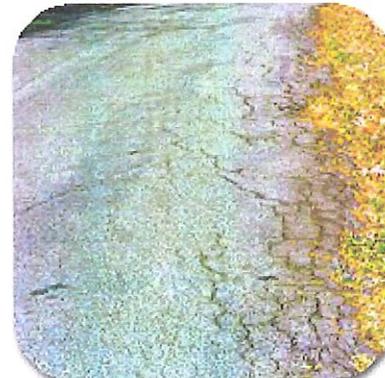
**Moderate:** Cracks more extensive and may be forming an alligator pattern; cracks are about 1/4 inch wide may be spalled.

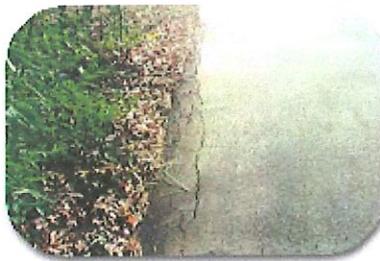
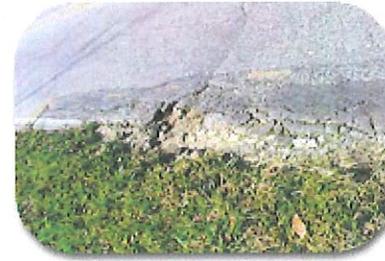
**Severe:** Cracks are alligatored and severely spalled; cracks usually 3/8 - 1/2 inch wide or greater; pieces may be loose and potholes may be present.

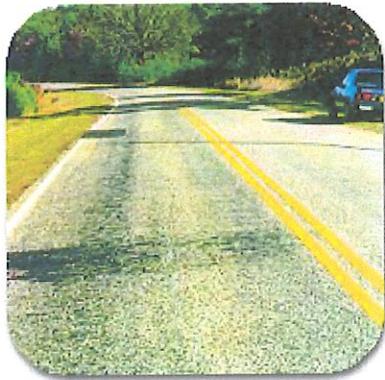
**Light:** Condition is present on 10 to 25 percent of the section.

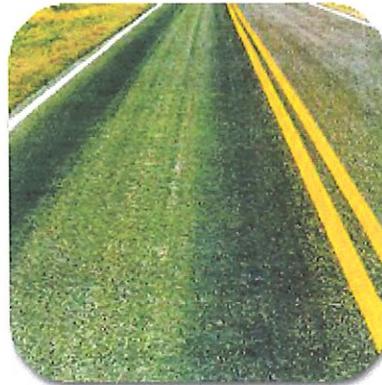
**Moderate:** Condition is present on 26 to 50 percent of the section.

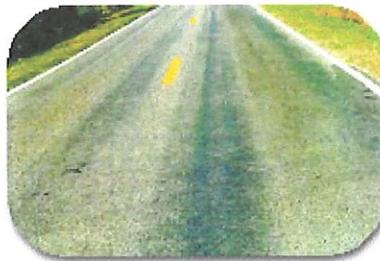
**Severe:** Condition is present on greater than 50 percent of the section.

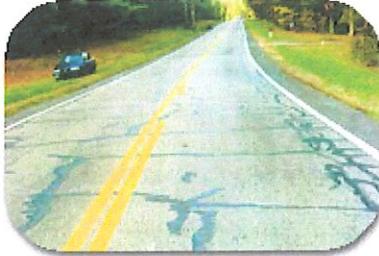
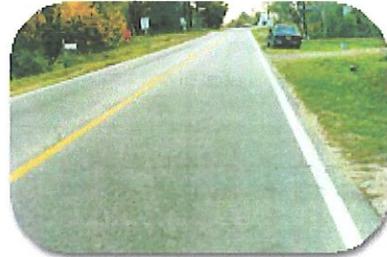
**Light:** Cracks, usually only transverse, are less than 1/4 inch wide and are not spalled; block pattern may not be visible yet; sealant is satisfactory if cracks have been sealed; transverse cracks usually 10 to 20 feet apart.

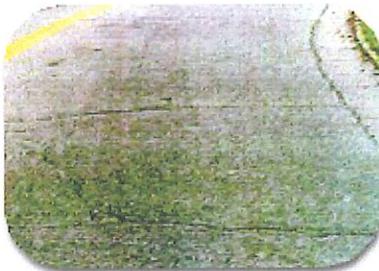
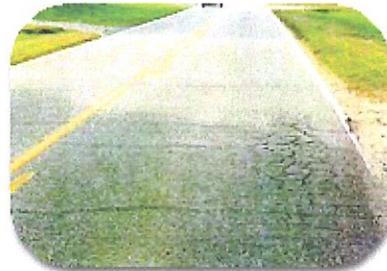
**Moderate:** Block pattern may be visible with blocks 10 square feet or greater present; cracks are 1/4 inch wide to less than 1/2 inch wide; cracks may or may not be spalled; transverse cracks usually 5 to 20 feet apart.

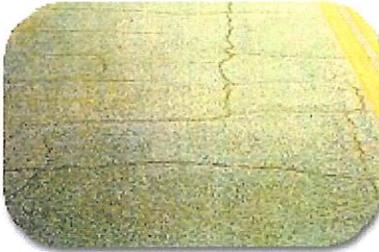
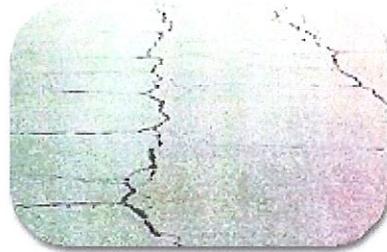
**Severe:** Cracks may be severely spalled with smaller blocks 2 to 10 square feet present; cracks usually about 1/2 inch wide or greater; transverse cracks may be 1 to 2 feet apart throughout portions of the surface.

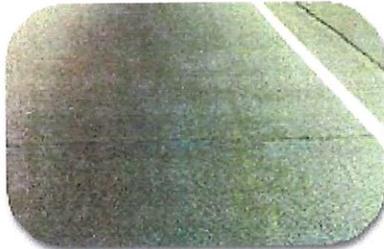
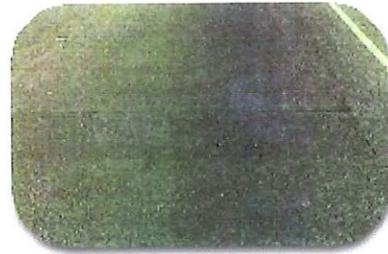
## TRANSVERSE CRACKING (REFLECTIVE)

**Light:** Cracks usually 1/8 to 1/4 inch wide; sealant is in satisfactory condition if present; cracks have little or no spalling; joints are usually not bumped up.

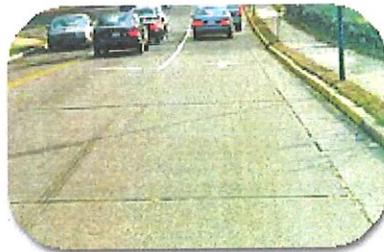
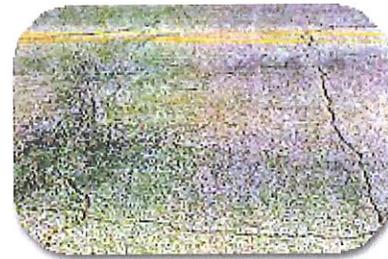
**Moderate:** Cracks are about 3/8 to 1/2 inch wide; cracks can be moderately spalled; joints may be bumped up 1/2 to 1 inch high.

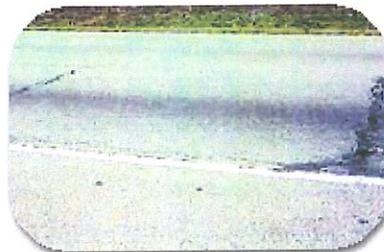
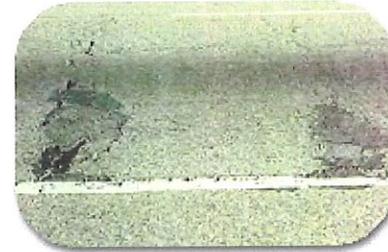
**Severe:** Cracks usually greater than 1/2 inch wide; cracks are severely spalled; joint may be bumped up greater than 1 inch high.

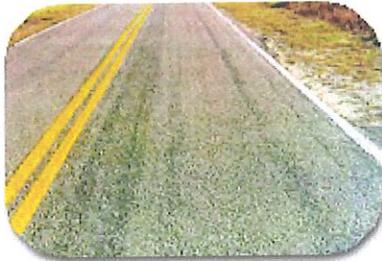
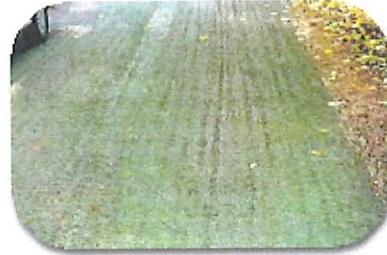
**Light:** Aggregate loss within the pavement lanes is not great; small amounts of pitting may be detected; aggregate or binder has started to wear away.

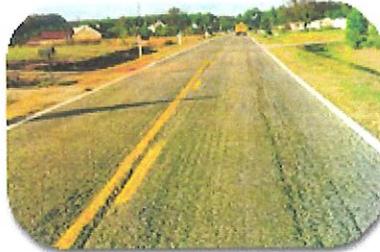
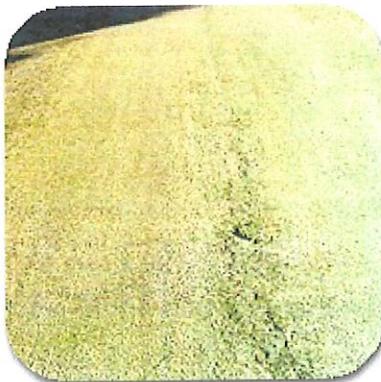
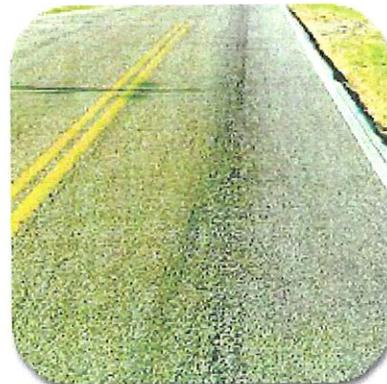
**Moderate:** Some pitting or stripping evident; random stripping with small areas (less than one square foot) or strips of aggregate broken away.

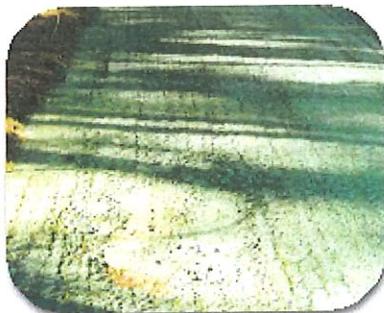
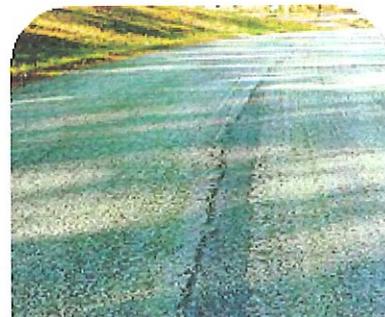
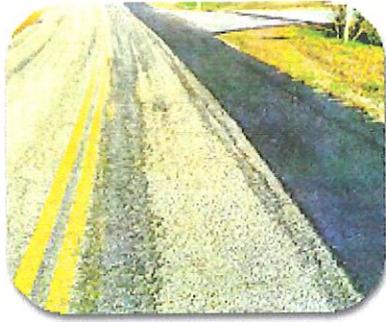
**Severe:** Stripping very evident; aggregate accumulations may be a problem; large sections (greater than one square foot) of stripping with aggregate layer broken away.

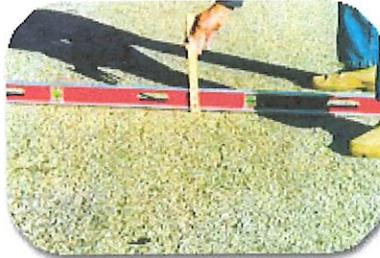
**Light:** Rutting 1/4 to less than 1/2 inch deep.

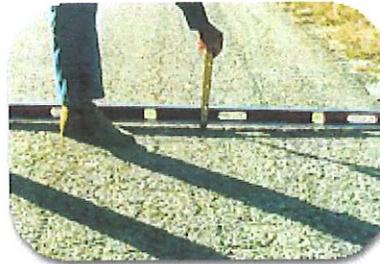
**Moderate:** Rutting 1/2 to less than 1 inch deep.

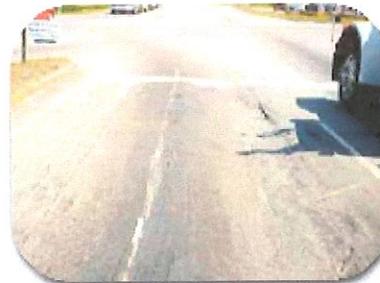
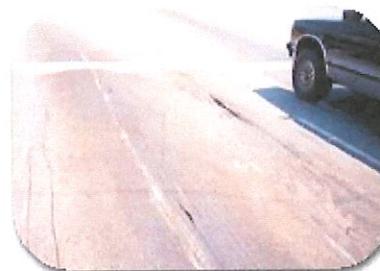
**Severe:** Rutting 1 inch deep or greater.
